Case 353 : Narrative

Case Vehicle (A): 2002 Chrysler	Vehicle (B): 1991 Chevrolet	Vehicle (C): 2000 Ford
Type: PT Cruiser, 4-door SUV	Type: Lumina, 4-door sedan	Type: Crown Victoria, 4-door sedan
Driver: 37-year-old male	Driver: 18-year-old male	Driver: 32-year-old male
CDC: 12-FLEE-7, 03-BYMS-1	CDC: 12-FLEE-6	CDC: 99-0000-0

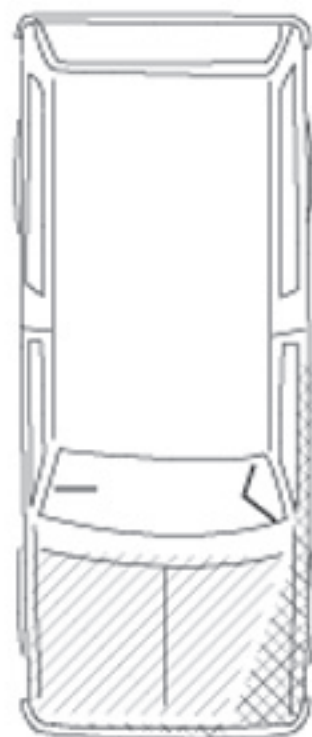
MEASUREMENTS IN CENTIMETERS

tears in windshield

Original
Bumper Height

[4](#) Damage to the front and left side of case vehicle (A) was severe. Direct damage began at the left-front bumper corner and continued 40-cm to the right, resulting in 27-percent vehicle overlap (VOL). The maximum crush at the bumper level was 44 cm and occurred at the left-front bumper corner. [5](#) Due to the initial narrow front-end engagement, direct damage continued down the left side of the vehicle and involved most of the driver door but stopped short of the B-pillar.
